METAL FATIGUE IN VESSEL STRUCTURES DUE TO DYNAMIC MOVEMENT

Abstract: Metal fatigue that occurs due to dynamic movement in a vessel. Two case studies using reliability engineering are diagnosed with modern technology, using vibration analysis and laser alignment on their propulsion systems. These types of ships have characteristics where both have different hull structure and material type; dynamic movement will occur no matter the features of the vessel. In both studies, it was found that the propulsion systems were not installed correctly and dynamic movement was detected which results in the re-occurring faults that the vessels were experiencing. The understanding of reliability engineering needs to be used when diagnosing metal fatigue.

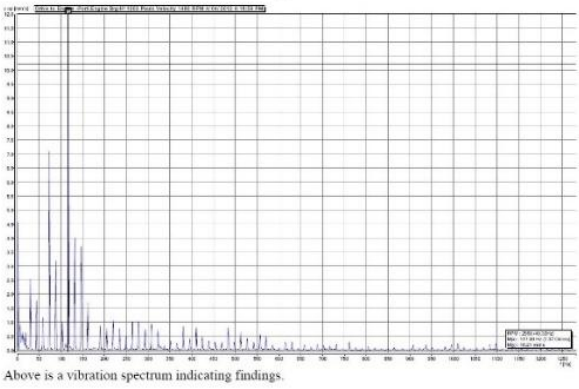
Figure 2 – VA misalignment spectrum

The three different rpm ranges tested were at idle at 1000rpm, 1450rpm and full speed at 1900rpm. The readings showed that there was an increase in misalignment, this was a good indication of dynamic movement occurring, as shown in figure 2.

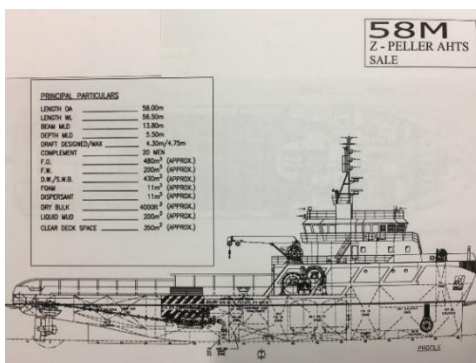
Figure 5 -Vessel y

Vessel *y* is a 58m displacement hull that has two medium revving diesel engines at 3500hp with a Z-drive thruster (see figure 5).

- High vibration that was felt throughout the ship at most rpm ranges.
- Bolts were loosening on bearing 1 on both Starboard and Port first intermediate shaft.
- Welds were cracking on the base plates of bearing housing 1 on both Starboard and Port intermediate shaft 1.
- Overheating on bearing 6 both Port and STBD intermediate shafts.

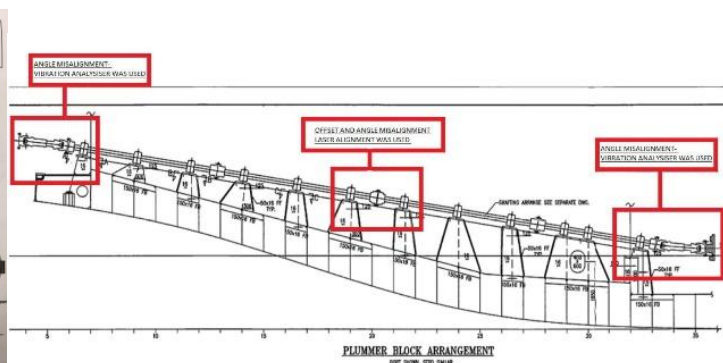
Figure 6 – VA misalignment position

The three different readings were at idle 450rpm, 600rpm and full speed of 750rpm. Readings showed that there was an increase in misalignment, this was a good indication of dynamic movement occurring. Offset and angular misalignment was observed at each coupling and Cardan shafts (see figure 6, highlighted in red).

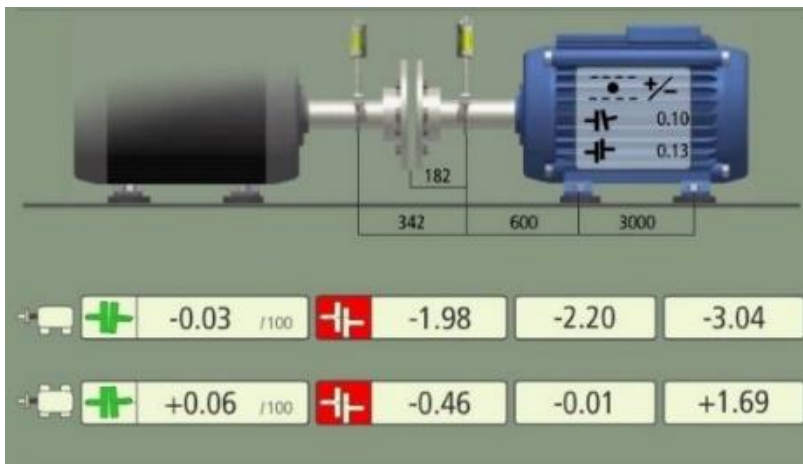
Figure 7 – Shaft alignment result

Executed alignment measurements throughout the drive train both Port and Starboard. Figure 7 is the reading from the coupling between the two intermediate shafts. This was the indication that bearing six would be over heating due to the misalignment. It was revealed that bearing 6 was a thrust bearing which was not designed to hold an 8m shaft on a 7 degree down angle. Offset brackets are used for aligning Cardan shafts, although this couldn't be done due to the intermediate shafts being at an angle of 7 degrees, therefore a third test was required.

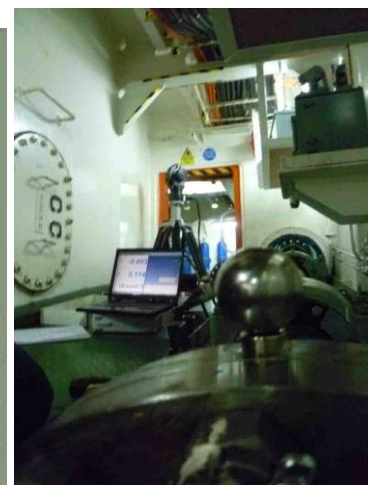
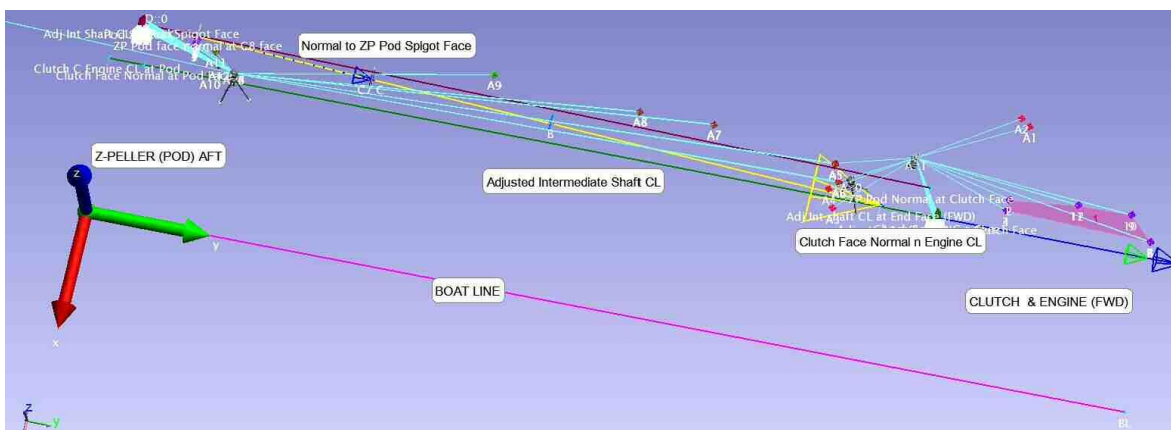
A 3D laser Tracker was used to undertake this test due to complexities of the drive train system. To begin the alignment the engine block was used as the reference, then the tracker zeroed in the coupling on the clutch box, both intermediate shafts and Z-drive thruster. The distance between the clutch box and Z-drive thruster was 16m apart. The offset misalignment was 13.7mm and the angle angular misalignment was 6.5mm. The two intermediate shafts had high stress applying to the bearing housing as these shafts carried the misalignment (see figure 8 and 9).

The vibration readings were over 12mm/s rms through the drive shaft. The starboard bearing 1 on the intermediate shaft was 23mm/s rms due to one loose bolt and cracked welds in the base plate. The intermediate shafts needed to be redesigned between the clutch box and the Z-

drive thruster. The Z-drive also required repositioning to be parallel to the clutch box. Neither of these modifications were an option at the time. With the 3D tracker, an accurate calculation could be made on the Cardan shafts. After looking at the specification of the Cardan shaft, the shaft works highly within the spline tolerance between the two universal joints. This spline allows for the absorption of axial loads when the couplings are not parallel with each other. The Cardan shaft was on the limit of its design for axial movement. Due to the maximum limit on the Cardan shafts when the dynamic movement occurs, the Cardan shaft then became overloaded. Causing the faults in bearing 1 such as the bolts coming loose and cracking welds in the base plate. This explains the high vibration throughout the whole vessel.

- Redesign the drive train between the clutch box and z-drive thruster as this will fix bearing faults, specially bearing 1 and 6.
- Introduce new alignment procedure with new drive train to allow for dynamic movement. The failure of the high vibration throughout the vessel will be minimised
